Manhole Inspection Summary

Manhole # S13UU1003MH

Insp Date: **4/10/07 10:38 AM**

Location Address: **BELVEDERE AVE**

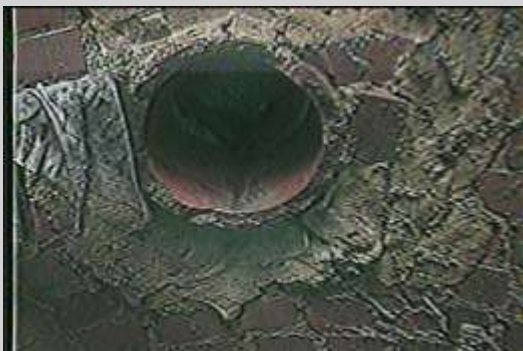
8 in. Circular Gravity Sewer Pipe In @ 5 O'Clock

Infiltration: **None** Pipe Seal Cond: **Unknown**

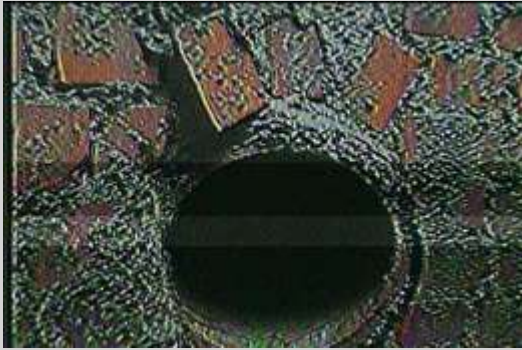
Pipe In @ 7 O'Clock

Infiltration: **None** Pipe Seal Cond: **Sound**

Drop: **Outside** Rod and Bar
Angled: **Yes** Reading: **9.26** (ft.)
Inv Depth: **10.26** (ft.)
Drop Condition: **Clogged**

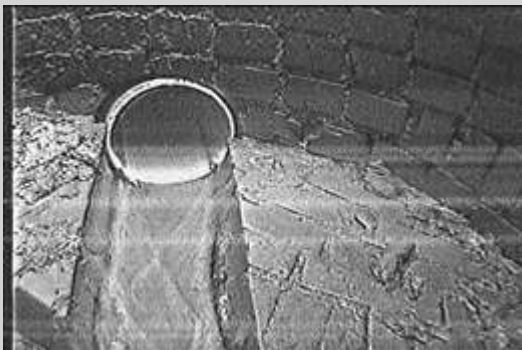
Pipe In @ 8 O'Clock

Comments **The l8 pipe seal is not flush to the pipe.**

Infiltration: **None** Pipe Seal Cond: **Unknown**
